# Project Case Study: South Thoresby Quarry, Lincolnshire

Services: Minerals Planning; Restoration Landscape Design

Project: South Thoresby Quarry – Face Stabilisation

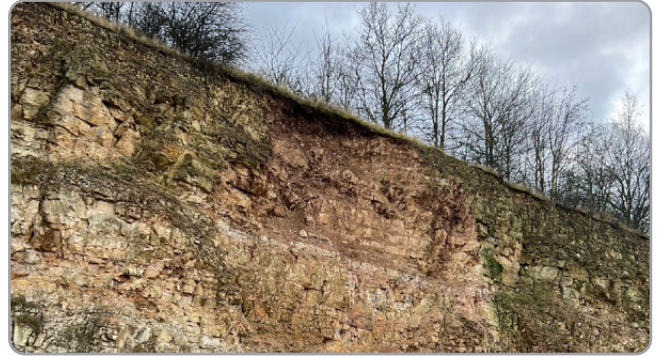
The current high risk chalk faces at South Thoresby Quarry

The Geotechnical Assessment for the site identifies "significant hazards" on the historical faces of South Thoresby Quarry (see photo). Whilst regular face monitoring with edge protection and rock traps have been undertaken additional measures were required to address the face stability of these historical chalk faces in the long-term.

The revised restoration profile required an estimated 81,000m<sup>3</sup> of additional material to be imported to site to facilitate increased backfilling against the current high risk chalk faces.

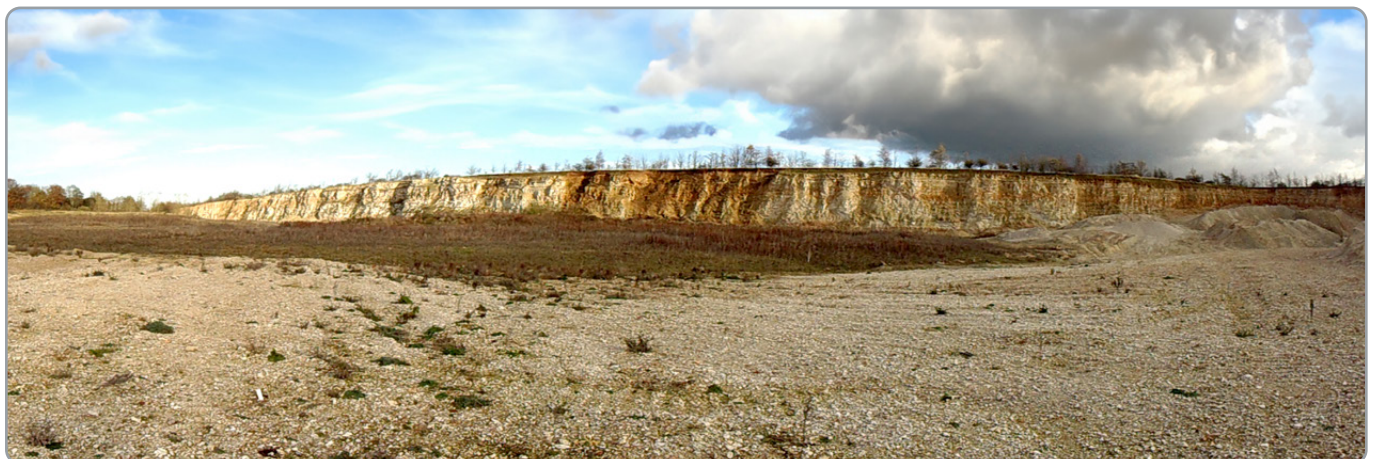
Historic faces of the South Thoresby Quarry

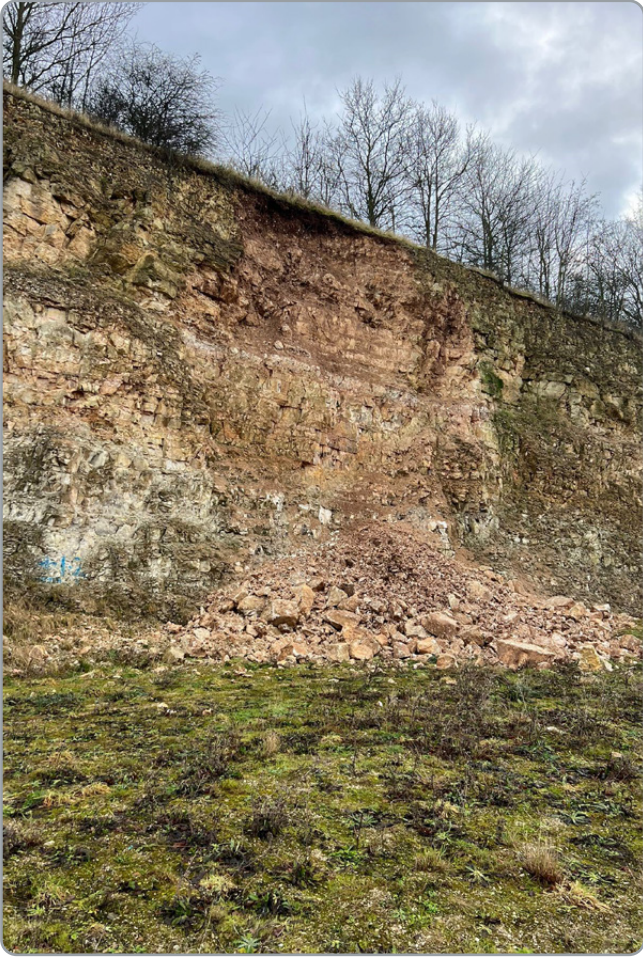
Localise face failure

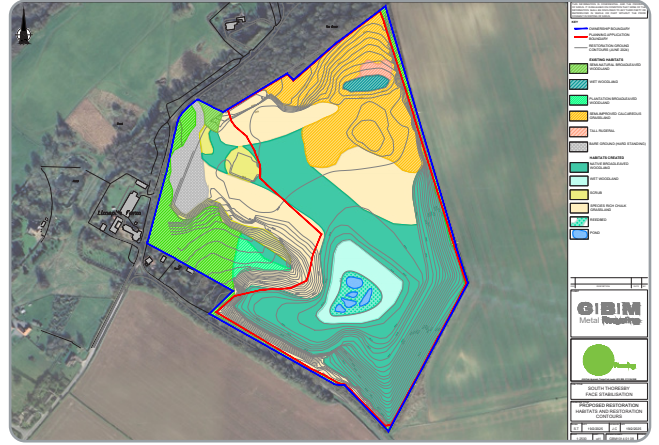
Proposed Restoration Habitats

As result of the changes to the restoration profile of the quarry, minor amendments are required to the approved scheme of landscaping.

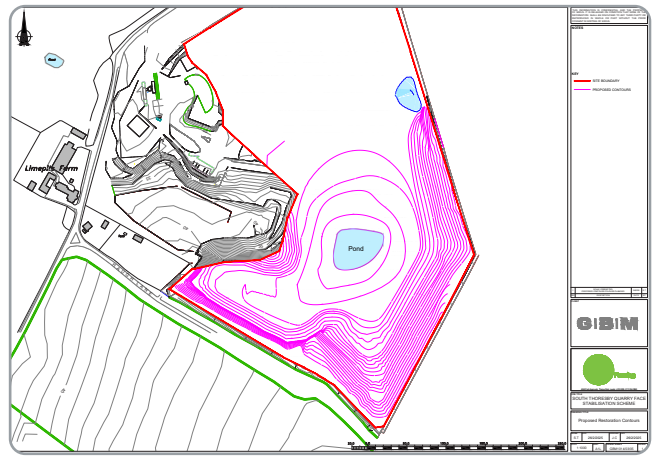
Proposed Restoration Contours

Sirius Planning prepared a planning application to vary the conditions of the existing consent to revise the approved restoration profile.
